WEST VIRGINIA STATE  
UNIVERSITY

# Campus Development Plan

2016 - 2025

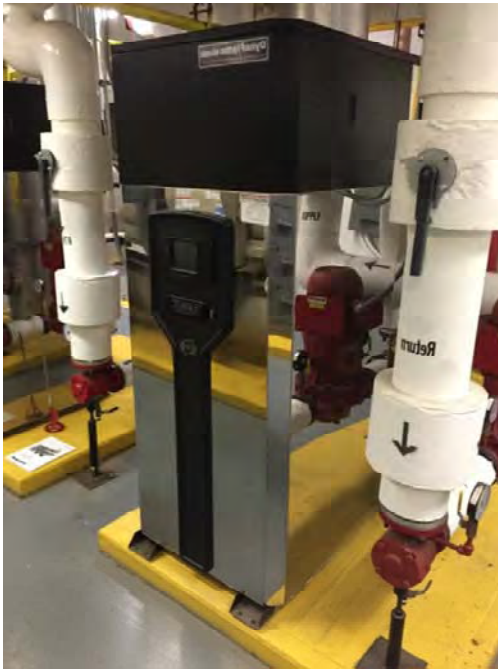
The central tower, nine floors of the building consisting primarily of office spaces, is served by several, aged, constant volume chilled/heating water air handling units, return/relief fans and space reheat coils. The AHUs are located in the third floor mechanical room. Chilled water is produced by a 2012 McQuay water cooled chiller, with a 1994 Evapco induced draft open cooling tower on the roof. Heating hot water is produced by new Camus DynaFlame high-efficient, condensing boilers. CHW and HHW pumps appear to be older but in decent working order. Most classrooms are served by aged, two-pipe unit ventilators or fan coil units. The unit ventilators have outdoor air louvers in the exterior walls for ventilation. Some classrooms were also provided with fin tube heaters, it's possible some unit ventilators are cooling only. There are hot water cabinet heaters located at most exterior entrances. Most of the main controls components are pneumatics with some new DDC controls and electronic actuators in the mechanical room. The majority of the space temperature sensors were units containing bi-metallic springs or mercury. Toilet rooms and Janitor's closets seemed to lack exhaust, or if exhaust was provided, insufficient.

It is recommended to upgrade/rebuild the existing air handling equipment with VFDs, DDC electronic controls, valves and sensors. New equipment will allow for updated sequences of operation including setback, demand control ventilation and variable speed operation. System pumps should be replaced or refurbished. Provide mechanical room with code compliant refrigerant sensing and evacuation. Space temperature sensors should be replaced with wireless, electronic sensors and any existing mercury thermostats should be properly disposed. Unit ventilators should be replaced and the building ventilation should be verified code compliant. Install or increase general exhaust in required spaces. Investigate the efficacy of converting from a 2-pipe to 4-pipe mechanical system. Budget the replacement of the existing cooling tower within the next 3-5 years (end of typical unit life span).

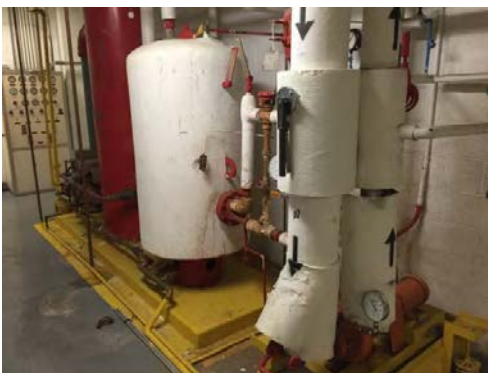
There is an 80% efficient Lochinvar domestic water heater/boiler, storage tank and circulating pump located in the basement mechanical room. The majority of the urinals and water closets are hands free flush valve type fixtures. The majority of the lavatories have handled faucets. No mixing valves were present at the lavatories which mean the DHW temperature is below 120 deg. F or scalding risks exist. There are electric water coolers throughout the building, some new, some were aged, and some were completely removed. The incoming water service is provided with proper backflow prevention. The building was previously utilized as more of a lab facility and the existing sanitary piping may be suspect.

It is recommended to replace the existing water heater with a high-efficiency, condensing, modulating gas water heater (Lochinvar). Perform a complete camera inspection of the existing sanitary piping

system to determine if there are issues with corrosion. Investigate the installation of point-of-use thermostatic mixing valves or utilize them for each toilet room or riser and begin to generate 140 deg. F domestic hot water.

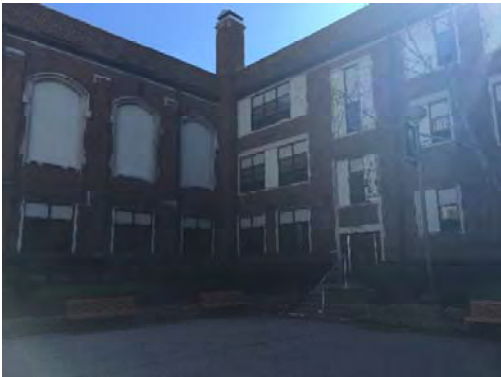
The exterior skin is an entirely brick structure with stone accents. The brick is in dire need of repointing. Water is coming through the walls at both side stairwells, and the interior walls have been repainted several times. The stone wrapping the building needs thoroughly washed. The windows have recently been replaced and are in good condition. The roof has also recently been replaced and is in good condition.

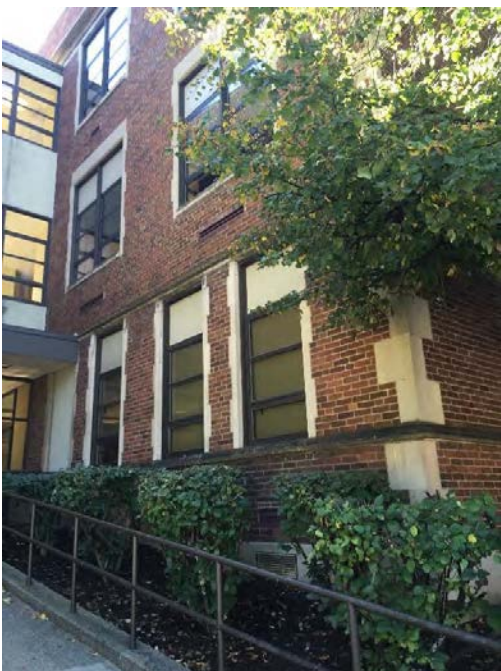
The entrances to Ferrell Hall are not ADA accessible. The existing ramps on either end of the building are too steep to meet ADA guidelines. Also, the main entrance from the quadrangle does not have a ramp. The auditorium entrance ramps do not meet ADA guidelines, and an accessible entrance to the stage is not available.

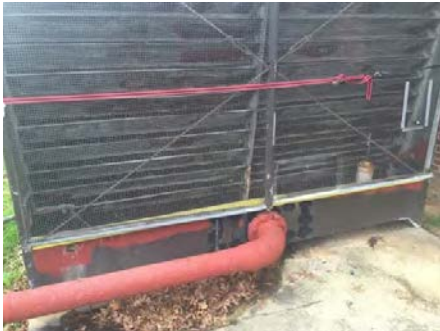
The central core of the building, Auditorium and lecture hall are served by several, aged, constant volume chilled/heating water air handling units. The AHUs are located in a mechanical room above the rear of the Auditorium. Chilled water is produced by a 1994 Trane water cooled chiller in the mechanical room, with an aged Marley induced draft, side discharge open cooling tower mounted on grade outside. Heating hot water is produced by two 75%+ efficient, gas-fired, 1965 Cleaver Brooks fire-tube boilers. CHW and HHW pumps appear to be older but in decent working order. The Auditorium stage is provided with ducted fan coils and fin tube heaters. Most classrooms are served by aged, two-pipe unit ventilators or fan coil units. The unit ventilators have outdoor air louvers in the exterior walls for ventilation. Some classrooms were also provided with fin tube heaters, but most unit ventilators appear to be heating and cooling based upon temperature of 2-pipe loop. Classrooms appeared to have gravity relief vents to relieve excess ventilation air. There are hot water cabinet heaters located at most exterior entrances. Automated Logic DDC controls are located in the upper level AHU mechanical room with a majority of the actuators and sensors DDC. The main boiler/chiller mechanical room has mostly outdated controls with the exception of the chiller. The majority of the space temperature sensors were units containing bi-metallic springs or mercury. Very limited controls equipment was observed outside the AHU mechanical room. Classrooms that require exhaust appeared to have operational exhaust fans. Toilet rooms and Janitor's closets seemed to lack exhaust, or if exhaust was provided, insufficient.

It is recommended to upgrade/rebuild the existing air handling equipment with VFDs, all DDC electronic controls, valves and sensors. New equipment

will allow for updated sequences of operation including setback, demand control ventilation and variable speed operation. Replace the existing 1965 boilers with high-efficiency, condensing boilers (Camus DynaFlame). Replace existing Marley cooling tower with a similar unit. All system pumps should be replaced or refurbished. Unit ventilators should be replaced and the building ventilation should be verified code compliant. Address relief vents using motor-operated dampers with differential pressure sensors once ventilation is restored. Provide ductwork on discharge of generator radiator; fix operation of backdraft damper. Space temperature sensors should be replaced with wireless, electronic sensors and any existing mercury thermostats should be properly disposed. Investigate the efficacy of converting from a 2-pipe to 4-pipe mechanical system. Install or increase general exhaust in required spaces Budget the replacement of the existing water-cooled chiller within the next 3-5 years (end of typical unit life span).

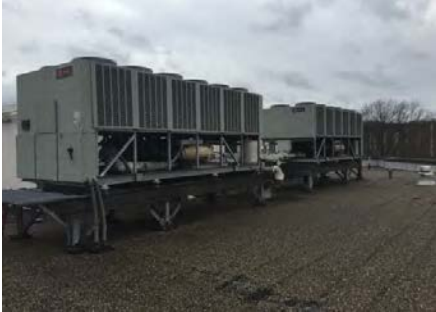
The majority of the building is served by two, large, built-up, chilled water/steam VAV air handling units located in a roof penthouse. There are zone-level terminal units with hot water reheat. Chilled water is generated by two, 2004, Trane air-cooled chillers located on the roof. Chilled water pumps are located in a penthouse mechanical/electrical room and look to be in good condition. Steam is produced by two, 80% efficient, Smith cast iron boilers in the basement mechanical rooms. Steam system includes a heat exchanger (convertor) for producing heating hot water (reheat), condensate receiver and boiler feedwater tank and pumping station. Automated Logic DDC controls are located in the basement mechanical room and penthouse pump room. Most steam and chilled water sensors, actuators and controllers were electronic DDC. All of the roof-mounted laboratory exhaust had no issues; stainless steel ductwork, VFDs and no-loss stacks. There was a mixture of DDC and aged space temperature sensors. There is a first floor Lecture Hall that is served by a packaged, DX and gas heat roof top air conditioning unit (RTU) with Automated Logic controls.

It is recommended to replace the steam condensate receiver and investigate any steam or condensate losses in the system. Space temperature sensors should be replaced with wireless, electronic sensors and any existing mercury thermostats should be properly disposed. Provide an additional application of a UV-protectant coating on the exterior chilled water elastomeric piping insulation at the chillers. Long-term considerations should be made to eliminate the use of steam within the building.

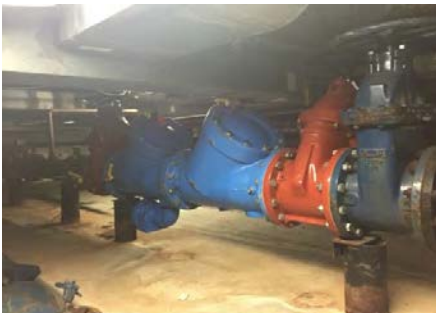
There is a high-efficient, power-vented, 80 gallon Lochinvar domestic water heater/boiler, Lochinvar storage tank and circulating pump located in the basement mechanical room. The majority of the urinals and water closets are hands free flush valve type fixtures. The majority of the lavatories have handled faucets. No mixing valves were present at the lavatories which mean the DHW temperature is below 120 deg. F or scalding risks exist. The incoming water service located within the crawl space is provided with proper backflow prevention. There is backflow prevention for the mechanical system make-up water. This building has laboratories throughout; the new portion of the building appears to be utilizing a complete polypropylene acid waste sanitary piping, the existing building sanitary piping is suspect and should be investigated further.

It is recommended to perform a complete camera inspection of the existing building sanitary piping system to determine if there are issues with corrosion. Investigate the installation of point-of-use thermostatic mixing valves or utilize

them for each toilet room or riser and begin to generate 140 deg. F domestic hot water.

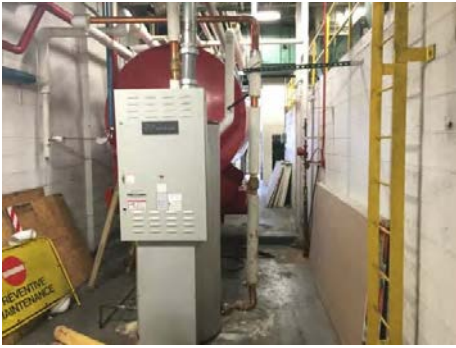
There is one Lochinvar 108 KW electric water heater, one Lochinvar 120 KW water heater, one 1000+ gallon hot water storage tank and recirculating pumps located in the penthouse mechanical room serving the east and west towers. Hot water equipment appears to be new and in good condition. The plumbing fixtures (showers, tubs, urinals, lavatories and water closets) were a hodge-podge of manufacturers and quality throughout the east and west towers. Some fixtures were newer with automatic flush valves, while others looked original and completely unusable. The sanitary piping is suspect throughout the entire building, what was visible appeared to be leaking and corroded. The majority of the lavatories have handless faucets. No mixing valves were present at the lavatories which mean the DHW temperature is below 120 deg. F or scalding risks exist. There are electric water coolers throughout the building; most appeared to be aged units. The incoming water service is not provided with proper backflow prevention. The basement sump pit, pumps, piping and accessories appears rusted/corroded and in need of replacement. Washing machines in the basement did not appear to have water hammer arrestors.

It is recommended to install a backflow preventer on the incoming water service. Remodel and update the majority of the plumbing fixtures (water closets, urinals, showers, tubs, water coolers and all sanitary piping) within the building. Investigate the installation of point-of-use thermostatic mixing valves or utilize them for each toilet room or riser and begin to generate 140 deg. F domestic hot water.

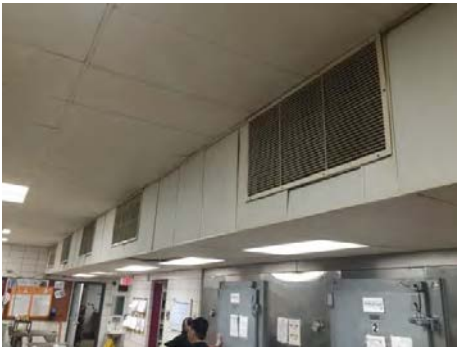
There is a suspended, hot water heating only, make up air (MUA) unit serving the kitchen. The MUA is located in the mechanical penthouse above the kitchen and is a 100% outdoor air unit. Because the MUA is not provided with any cooling, the kitchen can become uncomfortably warm. There are three walls that have kitchen exhaust hoods and cooking equipment. Some of the exposed ductwork appears to be galvanized as opposed to code-required, welded stainless steel or sheet steel. There are three kitchen exhaust fans on the roof; two of the kitchen exhaust fans are long past their expected life span. There are gravity (assumed) make-up air intake hoods that are ducted to the inlet of the kitchen hoods. The gravity approach to providing kitchen exhaust make-up air is inefficient and no longer recommended. The dish machine is provided with ductwork and an exhaust fan; no issues observed with dish machine exhaust (aluminum or stainless). The pressurization between the kitchen and adjacent spaces is not correct, as evidenced by the highly observable airflows into the kitchen at any doorway.

It is recommended to investigate reusing as many of the existing exhaust hoods as possible for any future remodeling. Rework all kitchen exhaust ductwork to be code-compliant. Provide new, variable speed exhaust fans with temperature and/or smoke sensors in the kitchen hoods to only increase the exhaust airflow as cooking demand requires. Provide a cooling coil in the MUA; either chilled water or split DX to allow for some cooling within the kitchen. Provide variable speed, fan forced, heating only, kitchen make up air units designed to meet the majority of kitchen exhaust needs (eliminate gravity hoods) and interlock with variable speed exhaust fans. Provide MUA plenum diffusers along the front edge of all kitchen hoods.
