SBS Project No. 11260

WEST VIRGINIA UNIVERSITY  
ROBERT C. BYRD HEALTH SCIENCE CENTER  
Infrastructure Upgrade Master Plan  
May 31, 2013

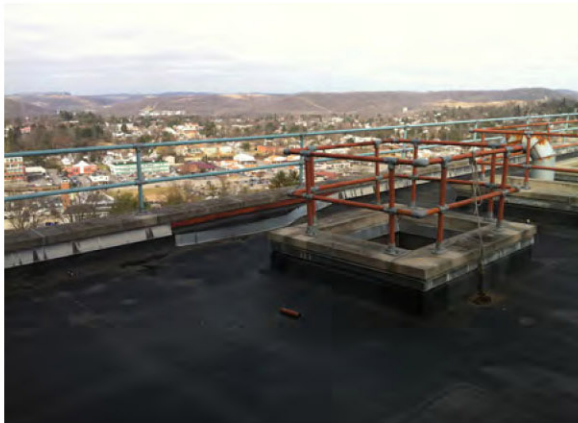
HSC South Roof showing the condition of the roof membrane and parapet cap flashing in need of replacement.

Based upon Kalkreuth's review of the roofs, the design team recommends vetting their initial inspections with an independent building envelope consultant. If that independent review concurs with Kalkreuth's assessment, we believe it is in the Owner's best interest to replace roofs that need immediate and short term replacement and shift the remaining acceptable roofs into long term projects. Where new equipment is to be placed on existing rooftops, coordinate with the schedule of the roof replacement project. Where heavy traffic is expected on existing roofs to be re-roofed as part of this scope of work, roof replacement shall follow to minimize traffic on new roof systems. Proposed rooftop equipment should be installed on roofs, where possible, that are scheduled for replacement. Roof replacement is defined as: demolition of the existing EPDM roof sheet, insulation cover board and the roof insulation. After demolition of the EPDM Roof, cover board and insulation underlayment, replace the existing roof with new rigid insulation, cover board and EPDM roof with a minimum of R20 and a warranty of 20 years. The existing roof drains are to be replaced with retrofit drains allowing adjustment of the height of the drains above the existing roof slab, for roof insulation to be tucked in between the concrete roof slab and the drain. This would meet the requirements for a R20 insulated roof. The basis of design is a Firestone fully-adhered EPDM System consisting of 1/2" Isoguard HD coverboard and their .060 mil black non-reinforced EPDM membrane. A possible value engineering option is to review the rigid insulation beneath the cover board and replace all insulation that has been water damaged. If the insulation is in very good shape, proceed with the installation of a fully adhered EPDM roof with a new cover board, hammer drilled through the existing insulation into the concrete roof deck below (hammer drilling restricted to before 8:00am). Survey all parapet cap flashing and precast concrete parapet caps, inspect for damage, and repair and/or replace as needed. A list of roofs broken down by floor and building: (see the attached roof plan for corresponding list of roof sections; i.e. N60)

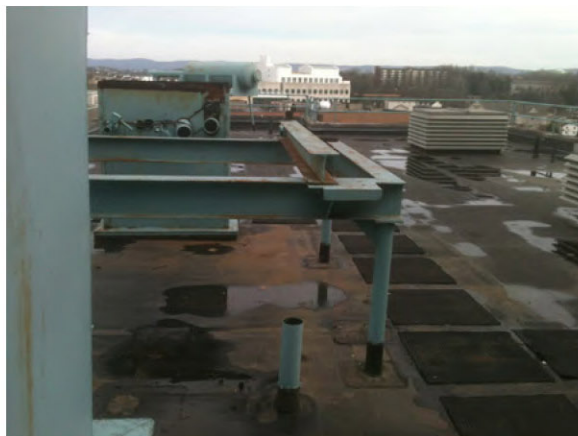
HSC North Roof showing the condition of the roof membrane that is in need of replacement.

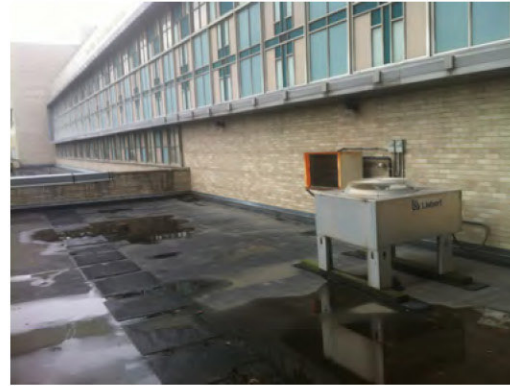
HSC South Roof showing the condition of the roof membrane that is in need of replacement.

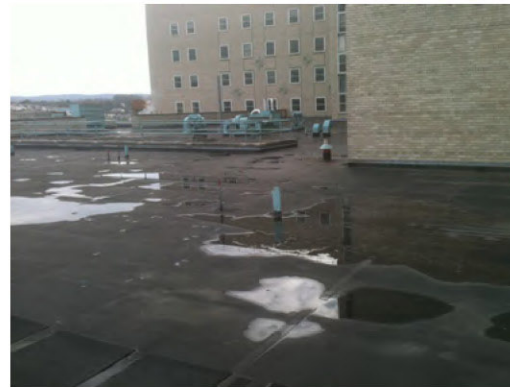
HSC North Roof showing the condition of the roof membrane that is in need of replacement.

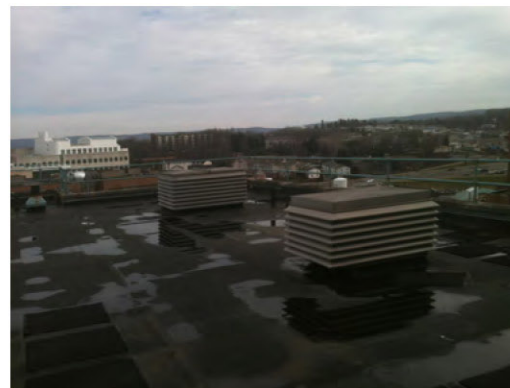
HSC North Roof showing the condition of the roof membrane that is in need of replacement.

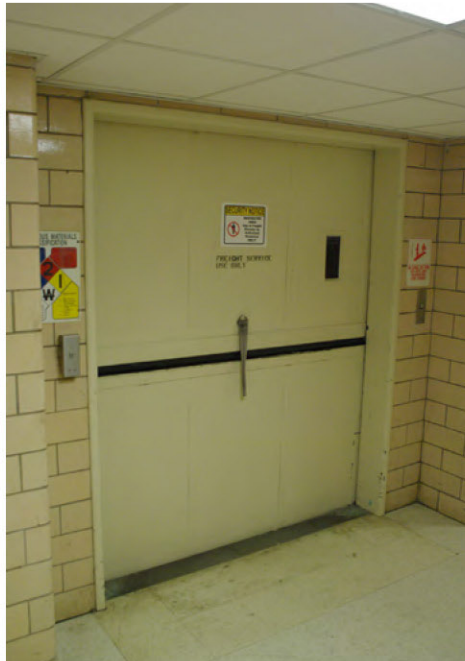
The existing service elevator does not directly access the roof and it is no longer as reliable as Facilities Management requires. It is original to the building and has reached the end of its useful life. In addition, the load capacity is less than similar sized contemporary elevators.

Freight Elevator  
Corridor Door  
Opening

A structural review of the hoistway beam and all other existing building elements affected by the new elevator and/or dumbwaiter will be performed. The project will modernize by installing a new hoistway beam (based on structural review & recommendation), cables (railslung), counterweights, sheaves, etc. A new wall partition enclosure to be provided around the new elevator /dumbwaiter. For the new elevator, an elevator machine room would need to be located, exact location to be determined. The proposed scope of work shall be reviewed with the State Fire Marshal and State Elevator Inspector.

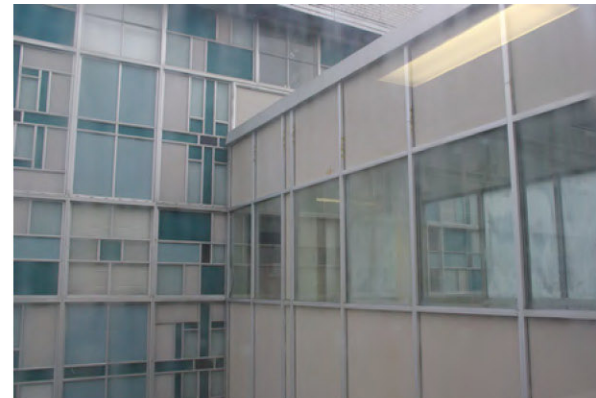
The curtainwall and roof of the Bridge are leaking water and air, having an adverse effect on the thermal comfort and appearance of the space.

The existing curtainwall will be replaced with a new curtainwall. The roof of the bridge will be replaced per the direction given in the replace the HSC roofs section of this report. The interior ceiling and floor finishes of the bridge will have all damage repaired by replacing the finishes with HSC standard finishes. The new glazing systems will be double-paned with thermally broken frames.

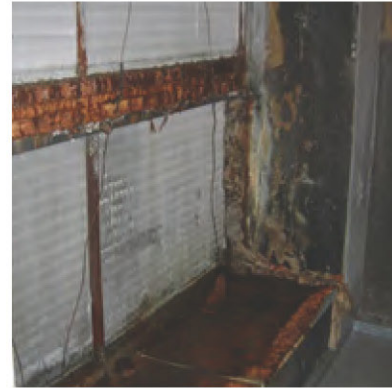
Typical condition of cooling coil within system 6 & 8 and the associated drain pan. This one has deteriorated to the point where condensate can no longer drain out of the unit, causing it to pool within the unit and increasing the potential for leakage through the base of the unit into the 4th floor below.

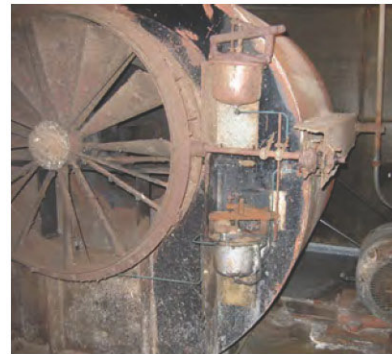
Typical condition of fan within system 6 & 8 – note the abandoned controls and inlet guide veins which increase system pressure drops and reduce overall performance.

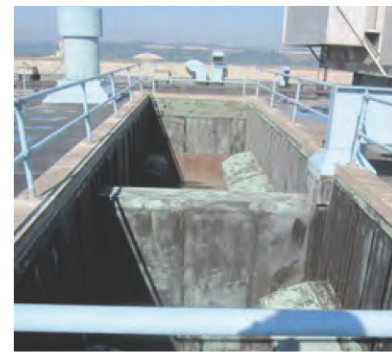
Depressed roof well currently used as an outdoor air intake for several 5th floor air handling units.

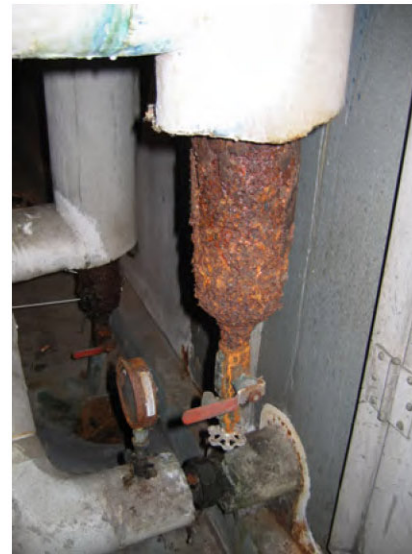
System 7 Piping showing extensive rusting of the piping and the need for replacement.

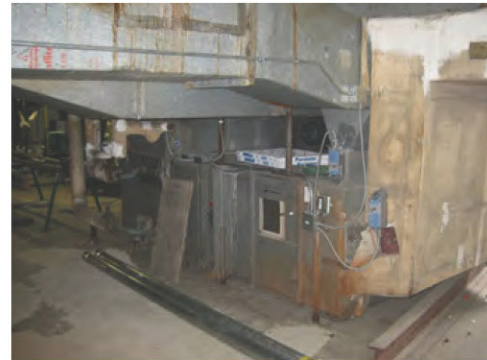
System 15 with supporting ductwork and controls – note the condition of unit casing and piping.

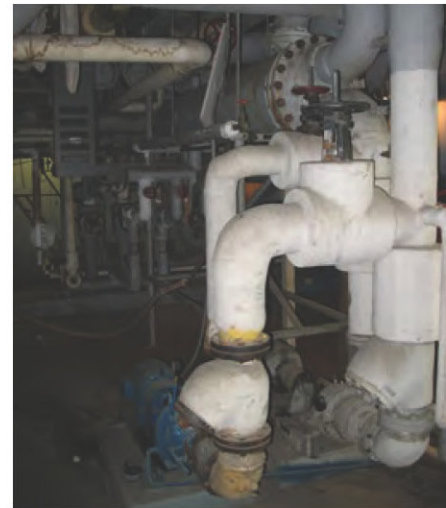
To support reheat coil replacement for approximately 120 zone coils located within the 5th floor mechanical room and replacement of induction systems 1 thru 4, this system will need to be replaced with a system having increased capacity. The existing system is 58 years old and in need of replacement.

Typical condition of 5th floor heat exchanger, associated piping and pumps.

Demolition of the existing system and replacement to be phased will have increased capacity. The system will consist of operating & standby variable speed pumps, circulating glycol through two heat exchangers piped in parallel. The approx. capacity of each is as follows:

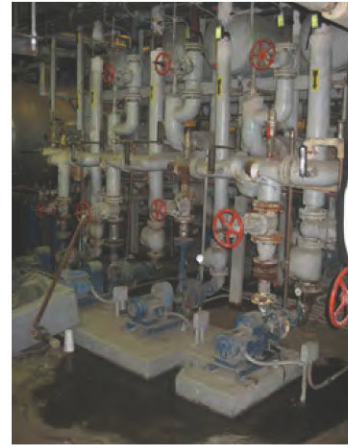
Note the condition of existing heat exchangers and pump sets as well as an indication of system leakage on the floor.

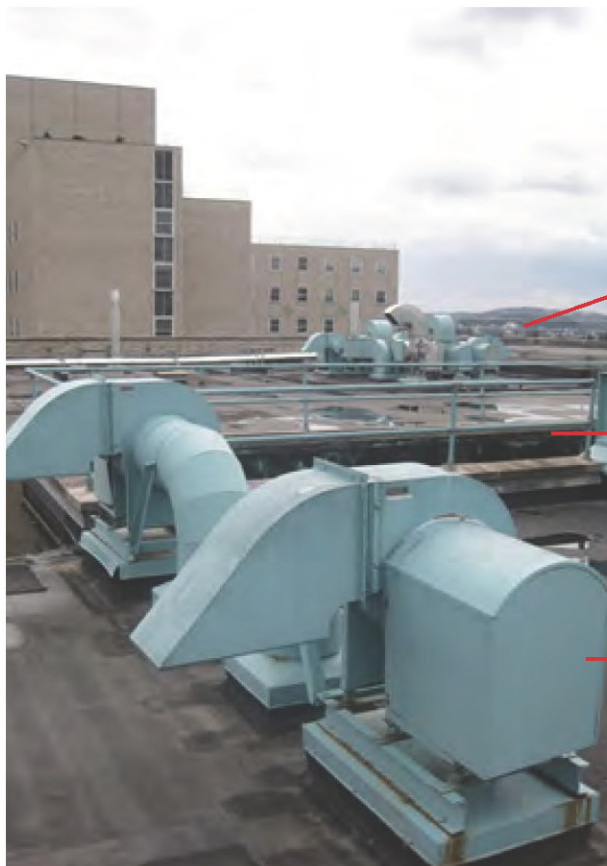
Typical exhaust fan arrangement.

Outdoor air intake serving 5th floor air handling units.

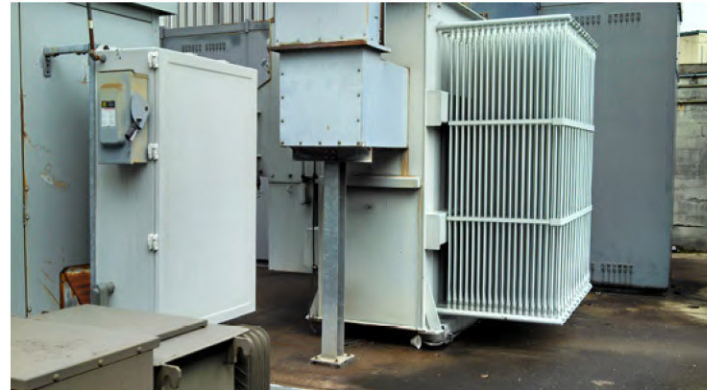
Testing these transformers should be scheduled as soon as possible due to the age and condition of the equipment. By performing preventive maintenance, the life of these transformers can be significantly extended, and the cost of replacement reduced by the cost of maintaining the transformers in good condition. Equipment of this type has a significant lifespan. Reduction in the lifespan is typically caused by operation outside of its original design parameters and degraded or low oil in the transformer enclosure, which increases the internal operating temperature and breaks down the insulation over time.

There are two work scopes associated with these transformers. The first is to institute a preventive maintenance plan. This should include an oil sample and testing for each transformer to determine its operating status and potential for failure. Additionally, load monitoring of these transformers should be verified to establish their current normal operating

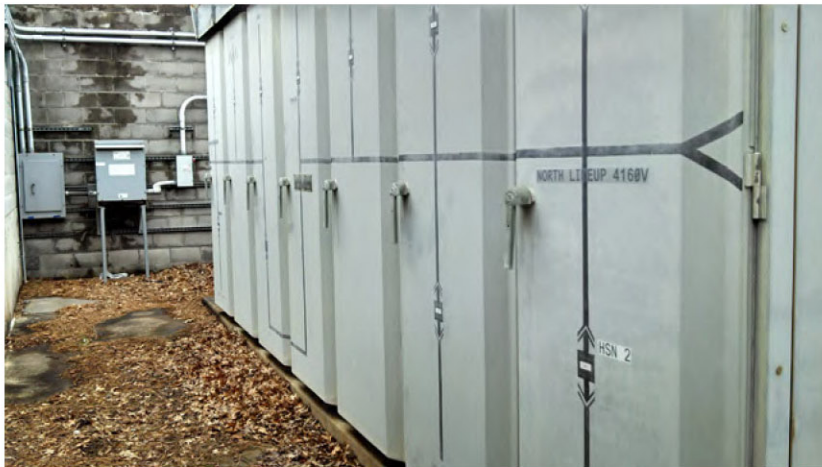
Scheduling and performing maintenance on this equipment will extend its life. Generally speaking, this type of equipment is made to be rebuilt and upgraded. When a problem is identified, it can be corrected and, in some cases, new components provided (such as digital relays as replacement for mechanical relays) which can update and significantly extend the life of this equipment. Preventive maintenance can identify system components which cannot be rebuilt or corrected, which may require system replacements, before there is a catastrophic failure that creates significant downtime and unplanned cost to the facility.

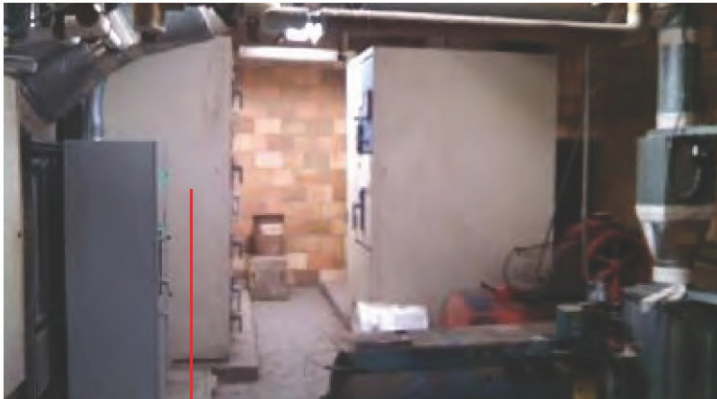
The South Power Centers are original to the building construction and have not been replaced or upgraded as have been the North Substations. There are no current known operational deficiencies with this equipment. The 4160 volt feeders from the south lineup to the power centers are mostly original conductors and should be replaced.

South Power Center PC-4 from the 1970’s. This equipment feeds the Cancer Center and is in poor condition.

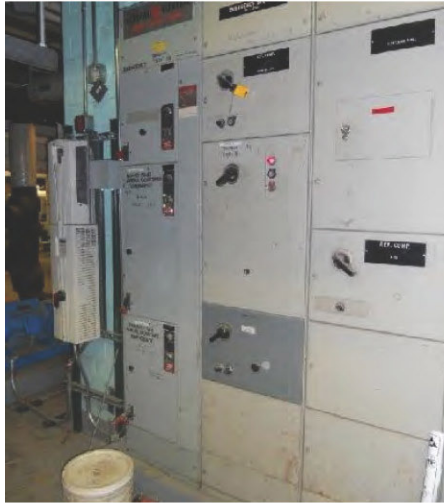
Typical MCC from original construction. Note new VFD which is a typical HVAC upgrade installation.

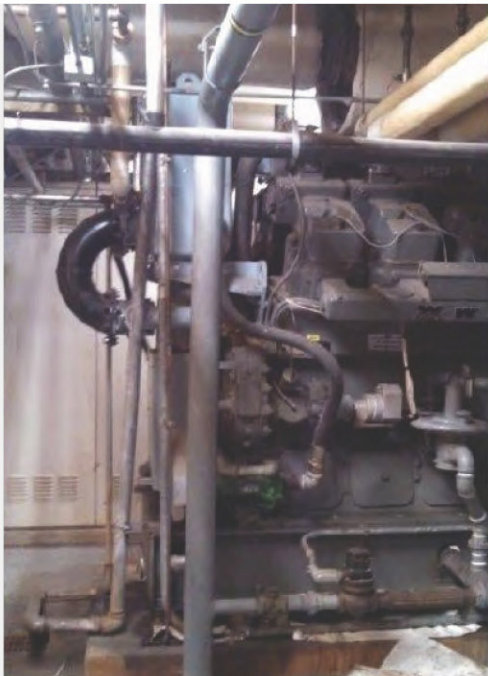
The ICU generator was installed in the early 70s in the HSC South 4th floor mechanical room. It is served by a power center which has reached the end of its useful life. The main power transfer switch for the distribution equipment is from 1970 and does not meet current codes and may or may not be operational. Additionally, a new transfer switch was installed to serve the Cancer Center expansion. The distribution system in the Cancer Center is minimal, and requests to expand this system to serve additional loads cannot be met. This generator is installed in a room which is extremely tight, and normal maintenance & operation are difficult. Replacement is not practical.

The south ICU generator is operable. Due to its age it should be scheduled for replacement. A study of loading and need for emergency power in the Cancer Center is needed.

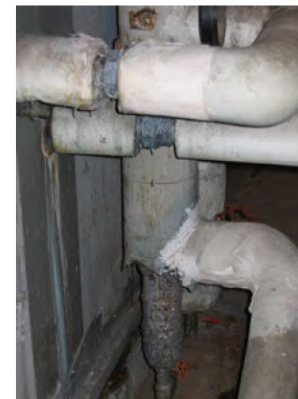
Domestic Cold Water piping showing the condition of the existing piping with rusting, leaking pipes insulated in asbestos insulation.

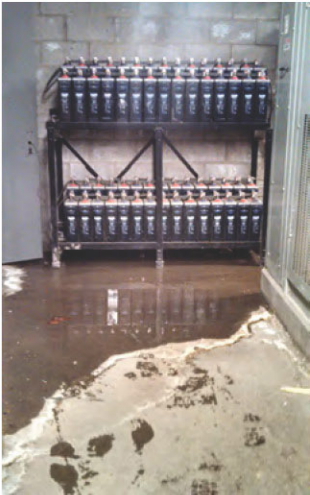
Existing floor drains located within the main electrical room periodically back up, flooding the area with standing water. This creates a hazardous environment for occupants and increases the potential for damage to the equipment in the space.

Standing water in Man Electrical Room beneath the Battery storage shelves creating a very hazardous condition.
