Shepherd University

2020 UPDATE: Campus Master Plan - 2014

VOLUME 1: 2020 UPDATE -- The 2014 Campus Master Plan

Appendix 1: Existing Building Assessments

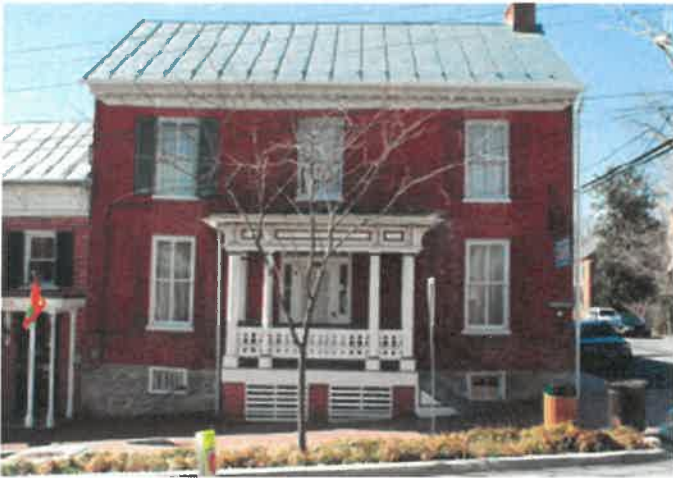
1. Conrad Schindler House (Civil War Center)

The Conrad Schindler House is a historic structure located apart from the main campus within the Corporation of Shepherdstown. It houses the George Tyler Moore Center for the study of civil war.

The structure is in good condition. It is primarily used as office space and houses the University's Center for the Study of the Civil War. Interior spaces received a general renovation in 2009 establishing the current three-office configuration. It is conditioned by a split system and fuel oil hydronic heat. The metal roof and gutter system requires replacement in the near future.

The building is in good condition overall, and is used as a repository for volumes related to the Civil War, some limited artifacts, and offices for the director and office assistant. Standard maintenance and upkeep will be performed as needed.

Continued improvements to complete the interior and maintain the exterior are recommended for the 10-year Campus Development Plan.

The building is currently listed on the Capital Priorities Plan. In an effort to save utility costs, the current fuel oil furnace will be scheduled for replacement with a more efficient propane gas system.

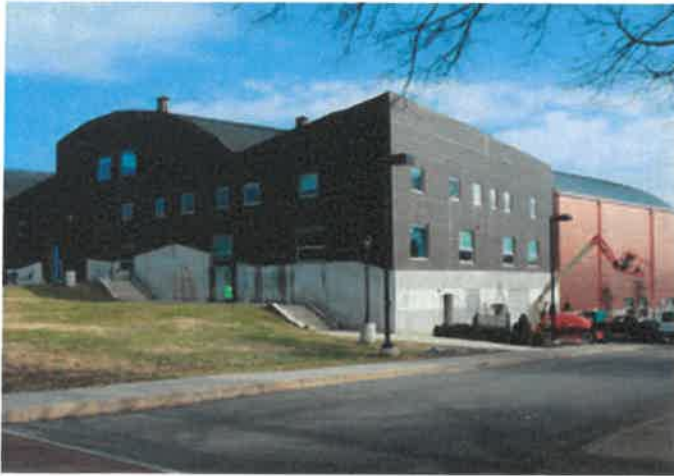
29. Center for Contemporary Arts II

Center for Contemporary Arts II, also referred to as CCA II, is the second building of a three building complex that houses the theater and arts programs, and is the companion structure to CCA I. This building contains the program elements and classroom spaces supporting Art and Theater programs and support areas for the same. It is one of several facilities used for the Contemporary American Theater Festival each year, and is a showpiece on the University campus.

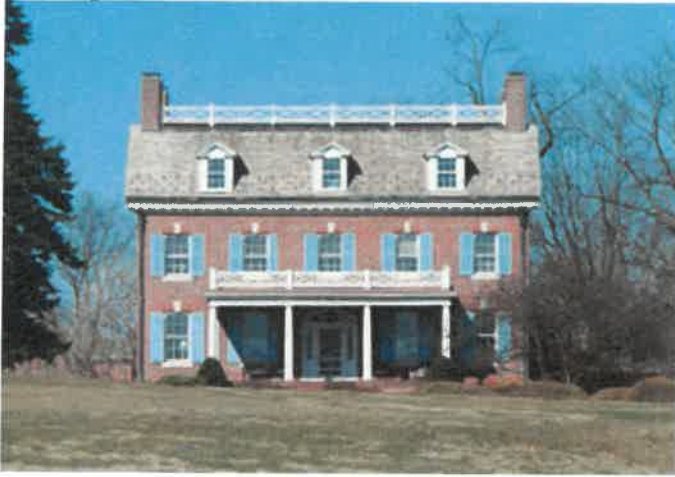
30. Popodicon

This building is a residential style structure. It was previously used as the President's residence, but it currently supports the University's entertaining, fund raising and campus retreat needs. The building is structurally sound and in good condition. It is ADA accessible. Popodicon is conditioned by propane hydronic heat and split systems. Maintenance needs include re-roofing, and repointing of the masonry. The stone foundation is somewhat porous and leaks in times of heavy rain. The railing on the roof is in need of replacement.

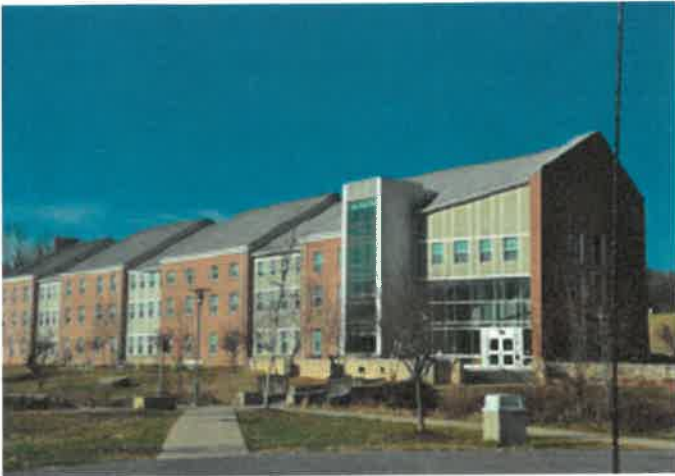
40. Dunlop Hall

Dunlop Hall, constructed in 2006, is in good condition. This building provides the mechanical systems for both itself and the adjacent Printz Hall for the building's HVAC systems. It is currently conditioned by a water cooled chiller and electric hydronic heat. Current maintenance needs will center on finishes, such as paint and floor coverings, over the course of the next 2 to 3 years. Kitchen cabinetry continues to experience premature failure, generally due to use conditions and initial construction quality of less than a commercial nature. The utility infrastructure is in constant need of repairs and maintenance. Major maintenance projects are performed annually.

The building is in good condition, but should receive more regular and consistent preventative maintenance. It will continue to be used as a residence hall, and is located in an area that has been designated for the same. Continued attention should be given to the operational efficiencies and utility usage.

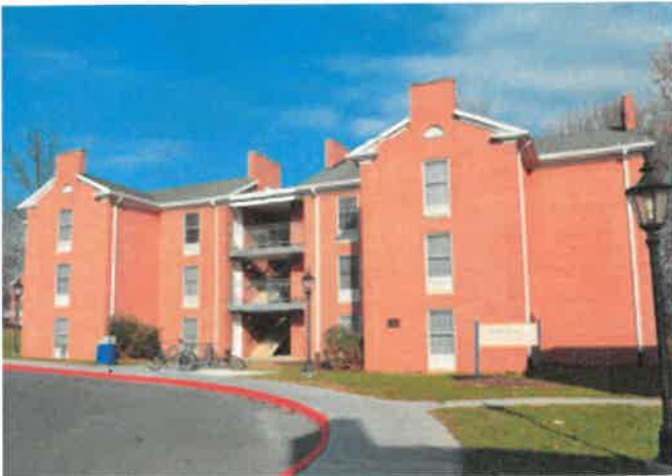
41. Martin Hall

Martin Hall is one of six suite style residential buildings, which collectively is referred to as Westwoods, and is located on west campus. This building is in relatively good condition; however, it is in need of mechanical and electrical upgrades. It is currently conditioned by Packaged Terminal Air Conditioner (PTAC) units. Minor upgrades were performed in 2012. The design for HVAC and electrical upgrades for Burkhart Hall would apply here, and are needed. Ongoing maintenance includes HVAC replacement, floor covering, envelope repair including masonry, roof and windows, and electrical upgrades.

The building is in fair condition, but should receive more regular and consistent preventative maintenance. It will continue to be used as a residence hall, and is located in an area designated as such. Continued attention should be given to the operational efficiencies and utility usage.

Martin Hall should continue to be properly maintained, and attention given to the maintenance items mentioned above. Because of insufficient air movement attributed to the original design of this building, the recent central HVAC system upgrades, if implemented, will significantly reduce the predominance of mold and mildew found here in the late summer and early fall each year. This design would be applicable to the rest of Westwoods as well. Before a new residence hall is constructed, the viability of the continued use of this and other Westwoods residence halls should be considered.

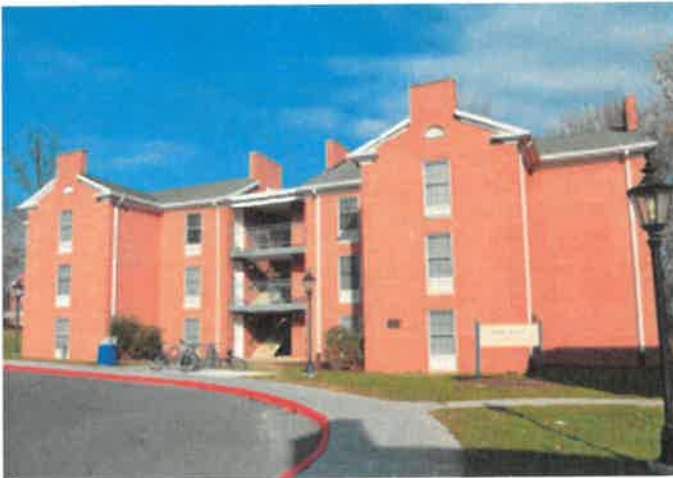
42. Lurry Hall

Lurry Hall is one of six suite style residential buildings which collectively is referred to as Westwoods, and is located on west campus. This building is in relatively good condition; however, it is in need of mechanical and electrical upgrades. It is currently conditioned by Packaged Terminal Air Conditioner (PTAC) units. Minor upgrades were performed in 2012. The design for HVAC and electrical upgrades for Burkhart Hall would apply here, and are needed. Ongoing maintenance includes HVAC replacement, floor covering, envelope repair including masonry, roof and windows, and electrical upgrades.

Lurry Hall should continue to be properly maintained, and attention given to the maintenance items mentioned above. Because of insufficient air movement attributed to the original design of this building, the recent central HVAC system upgrades, if implemented, will significantly reduce the predominance of mold and mildew found here in the late summer and early fall each year. This design would be applicable to the rest of Westwoods as well. Before a new residence hall is constructed, the viability of the continued use of this and other Westwoods residence halls should be considered.
