WEST VIRGINIA STATE  
UNIVERSITY

# Campus Development Plan

2016 - 2025

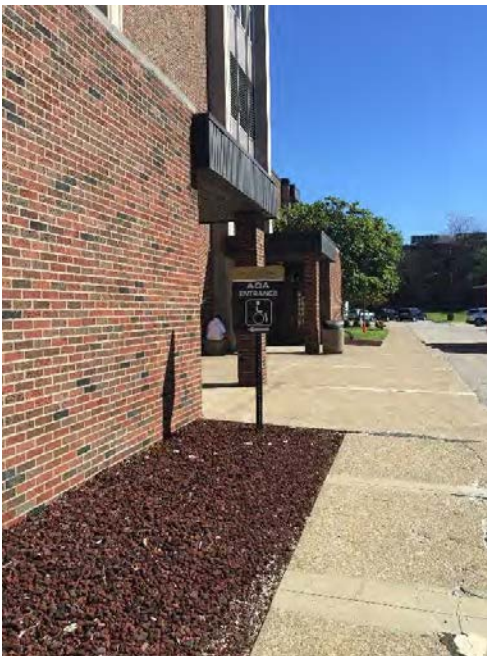
A drop-off loop is located directly off Rt. 25 at the front entrance. Parking is located on both sides of the building and a service road is located behind the building. The front first level entrance doors are ADA accessible, but do not have ADA operators and does not have an accessible approach from the closest handicap parking. No handicap parking is in proximity to these doors. An ADA entrance is located at the ground level rear entrance. This is the entrance most used by students on campus.

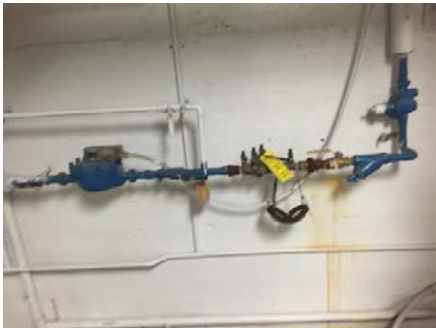
There is an 80% efficient, 40 gallon, gas-fired, commercial water heater located in the basement mechanical room. The majority of the urinals and water closets are hands free flush valve type fixtures. The majority of the lavatories have handled faucets. No mixing valves were present at the lavatories which mean the DHW temperature is below 120 deg. F or scalding risks exist. There are electric water coolers throughout the building; there was a combination of new and aged units. The incoming water service is provided with proper backflow prevention. There is a backflow preventer for the mechanical system make-up water.

It is recommended to investigate the installation of point-of-use thermostatic mixing valves or utilize them for each toilet room or riser and begin to generate 140 deg. F domestic hot water.

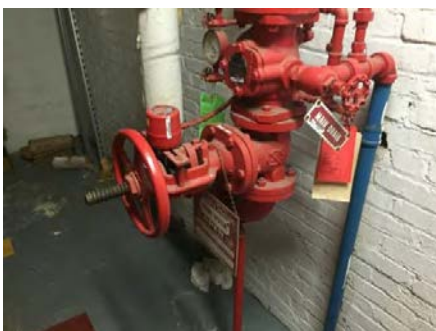
The majority of the building does not have a fire protection sprinkler system. There is a fire protection sprinkler system in the Auditorium with the main riser, backflow preventer and valve assembly in the basement mechanical room. Smoke detectors, pulls and fire extinguishers were observed in the building.

It is recommended to install a complete fire protection sprinkler system throughout the entire building.

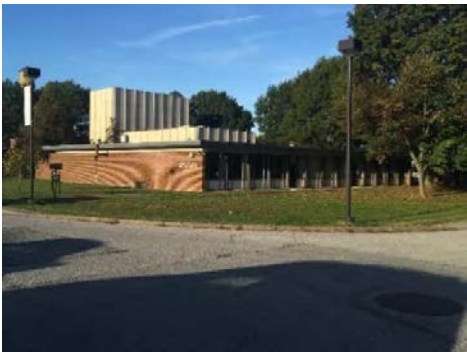
The exterior skin consists of brick and metal curtain wall glazing. The roof needs replaced very soon. The interior of the building consists of CMU walls, vinyl tile, and acoustical ceiling tiles. The finishes are dated and in need of replacement.

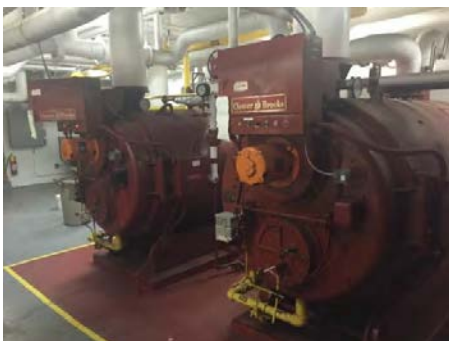
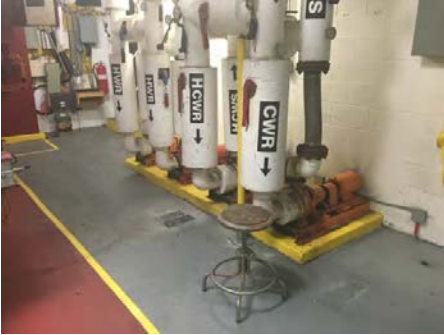
The central core of the building, Auditorium and lecture hall are served by several, aged, constant volume chilled/heating water air handling units. The AHUs are located in a mechanical room above the rear of the Auditorium. Chilled water is produced by a 1994 Trane water cooled chiller in the mechanical room, with an aged Marley induced draft, side discharge open cooling tower mounted on grade outside. Heating hot water is produced by two 75%+ efficient, gas-fired, 1965 Cleaver Brooks fire-tube boilers. CHW and HHW pumps appear to be older but in decent working order. The Auditorium stage is provided with ducted fan coils and fin tube heaters. Most classrooms are served by aged, two-pipe unit ventilators or fan coil units. The unit ventilators have outdoor air louvers in the exterior walls for ventilation. Some classrooms were also provided with fin tube heaters, but most unit ventilators appear to be heating and cooling based upon temperature of 2-pipe loop. Classrooms appeared to have gravity relief vents to relieve excess ventilation air. There are hot water cabinet heaters located at most exterior entrances. Automated Logic DDC controls are located in the upper level AHU mechanical room with a majority of the actuators and sensors DDC. The main boiler/chiller mechanical room has mostly outdated controls with the exception of the chiller. The majority of the space temperature sensors were units containing bi-metallic springs or mercury. Very limited controls equipment was observed outside the AHU mechanical room. Classrooms that require exhaust appeared to have operational exhaust fans. Toilet rooms and Janitor's closets seemed to lack exhaust, or if exhaust was provided, insufficient.

It is recommended to upgrade/rebuild the existing air handling equipment with VFDs, all DDC electronic controls, valves and sensors. New equipment

will allow for updated sequences of operation including setback, demand control ventilation and variable speed operation. Replace the existing 1965 boilers with high-efficiency, condensing boilers (Camus DynaFlame). Replace existing Marley cooling tower with a similar unit. All system pumps should be replaced or refurbished. Unit ventilators should be replaced and the building ventilation should be verified code compliant. Address relief vents using motor-operated dampers with differential pressure sensors once ventilation is restored. Provide ductwork on discharge of generator radiator; fix operation of backdraft damper. Space temperature sensors should be replaced with wireless, electronic sensors and any existing mercury thermostats should be properly disposed. Investigate the efficacy of converting from a 2-pipe to 4-pipe mechanical system. Install or increase general exhaust in required spaces Budget the replacement of the existing water-cooled chiller within the next 3-5 years (end of typical unit life span).

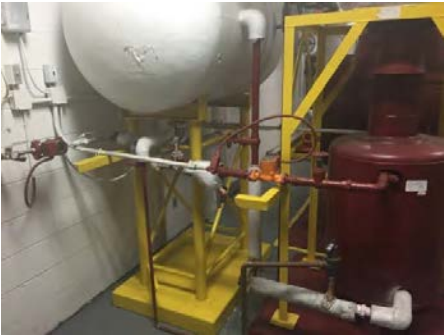
There is an 80% efficient, gas-fired, water heater, approximate 100 gallon storage tank and recirculating pumps located in the main mechanical room. The majority of the urinals and water closets are hands free flush valve type fixtures. The majority of the lavatories have handled faucets. No mixing valves were present at the lavatories which mean the DHW temperature is below 120 deg. F or scalding risks exist. There are electric water coolers throughout the building, most were aged. The incoming water service is not provided with proper backflow prevention. Backflow prevention is provided for mechanical system make-up water.

It is recommended to install a backflow preventer at incoming water service main. Replace the existing water heater with a high-efficiency, condensing, modulating gas water heater (Lochinvar). Investigate the installation of point-of-use thermostatic mixing valves or utilize them for each toilet room or riser and begin to generate 140 deg. F domestic hot water.

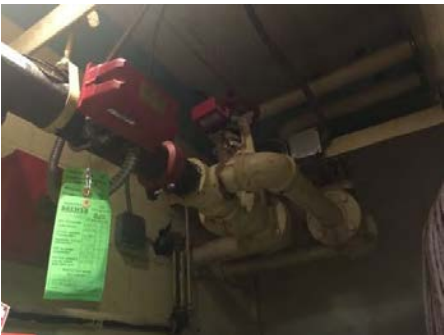
The majority of the building does not have a fire protection sprinkler system. There is a fire protection sprinkler system in the Auditorium with the main riser and valve assembly in an adjacent janitor's closet. The stage high-tower is provided with fire curtains and a smoke evacuation system. Smoke detectors, pulls and fire extinguishers were observed in the building.

It is recommended to install a complete fire protection sprinkler system throughout the entire building. Automate the smoke separation and evacuation system at the stage. Install backflow preventer for existing zone valve assembly.

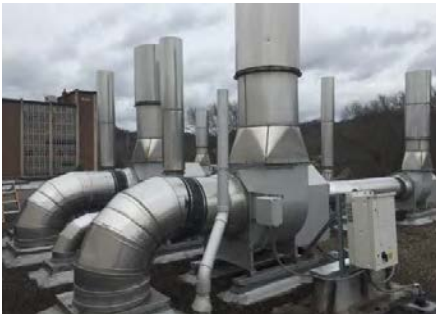
The majority of the building is served by two, large, built-up, chilled water/steam VAV air handling units located in a roof penthouse. There are zone-level terminal units with hot water reheat. Chilled water is generated by two, 2004, Trane air-cooled chillers located on the roof. Chilled water pumps are located in a penthouse mechanical/electrical room and look to be in good condition. Steam is produced by two, 80% efficient, Smith cast iron boilers in the basement mechanical rooms. Steam system includes a heat exchanger (convertor) for producing heating hot water (reheat), condensate receiver and boiler feedwater tank and pumping station. Automated Logic DDC controls are located in the basement mechanical room and penthouse pump room. Most steam and chilled water sensors, actuators and controllers were electronic DDC. All of the roof-mounted laboratory exhaust had no issues; stainless steel ductwork, VFDs and no-loss stacks. There was a mixture of DDC and aged space temperature sensors. There is a first floor Lecture Hall that is served by a packaged, DX and gas heat roof top air conditioning unit (RTU) with Automated Logic controls.

It is recommended to replace the steam condensate receiver and investigate any steam or condensate losses in the system. Space temperature sensors should be replaced with wireless, electronic sensors and any existing mercury thermostats should be properly disposed. Provide an additional application of a UV-protectant coating on the exterior chilled water elastomeric piping insulation at the chillers. Long-term considerations should be made to eliminate the use of steam within the building.

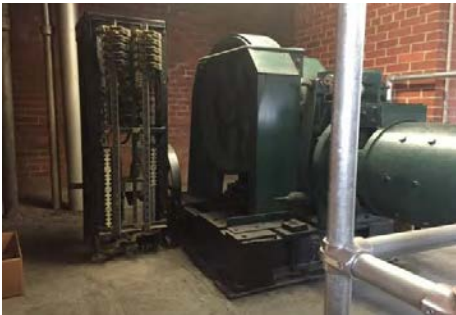
There are two separate elevators located in the building. The single car elevator located in the original portion of the building has outdated elevator machinery and controls located in the penthouse elevator machine room. The single car elevator located in the new portion of the building has new machinery and controls in a basement elevator machine room adjacent to the shaft. All of the elevator cars have the required Firefighters' Operation connections, communications and overrides.

It is recommended to update the machinery and controls for the single elevator car located in the original building.

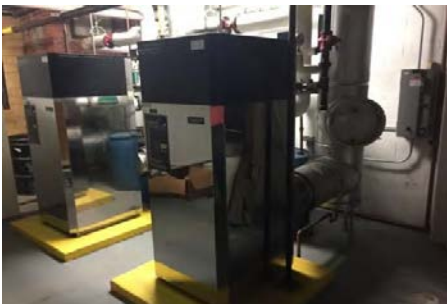
The majority of the building is served by 30 – 40, 5-ton or less, water source heat pumps (WSHP). WSHP's are ducted to serve offices, study and stack areas. Heat pump condenser cooling water is generated by an aged Marley, forced draft fluid cooler. Heat pump condenser heating and space heating water are generated by two, new Camus DynaFlame, high-efficient condensing boilers located in a basement mechanical room. Campus steam used to serve the building, but all steam equipment is abandoned and non-operational. There are new heating primary boiler pumps located near the boilers. The existing secondary condenser water pumps in a basement mechanical room are operational and appear to be in good condition. There are Automated Logic DDC controllers located in the basement for the condenser water heating and cooling system and also located at most WSHP's. There are existing, heating only unit convectors located along the perimeter of the building beneath the windows. There is an existing make-up air unit in the basement which is no longer operational since the steam coil was removed. It is believed this unit is responsible for providing the code-required ventilation to the building. There was a mixture of DDC and aged space temperature sensors. There are hot water cabinet heaters located at most exterior

entrances. Toilet rooms and Janitor's closets seemed to lack exhaust, or if exhaust was provided, insufficient.

It is recommended to replace the existing Marley fluid cooler with a similar unit. Continue to replace the small WSHP's as required (upon failure). Rebuild (with upgrades), or replace the existing make-up air unit in the basement to provide code-required ventilation to the building. Keep the perimeter convectors to maintain building historical architectural character. Space temperature sensors should be replaced with wireless, electronic sensors and any existing mercury thermostats should be properly disposed.

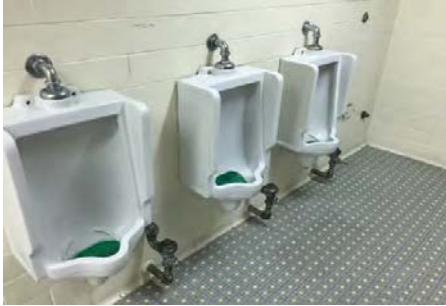
There is an 80% efficient, 40 gallon, gas-fired, commercial water heater and recirculation pump located in a basement mechanical room. There was a mixture of urinals and water closets with hands free flush valve type fixtures, while others were foot-operated or hand operated flush valves (most of the older fixtures were in the basement). The majority of the lavatories have handled faucets. No mixing valves were present at the lavatories which mean the DHW temperature is below 120 deg. F or scalding risks exist. There are electric water coolers throughout the building; there was a combination of new and aged units. The incoming water service is not provided with proper backflow prevention.

It is recommended to install a backflow preventer at incoming water service main. Replace the remaining fixtures that require hands free (automatic) flush valves. Investigate the installation of point-of-use thermostatic mixing valves or utilize them for each toilet room or riser and begin to generate 140 deg. F domestic hot water.

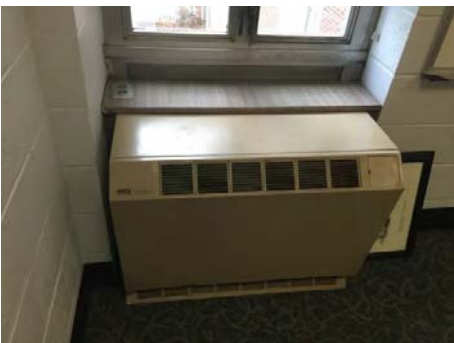
The front entrance/corridor connecting Sullivan to the Student Union is served by a packaged DX roof top unit (RTU). All of the dorm spaces appeared to have aged Singer Remington packaged terminal air conditioner (PTAC) units with DX cooling and electric heat. There were two, exterior mounted BARD units serving some lower level office or classroom spaces. Toilet rooms and Janitor's closets seemed to lack exhaust, or if exhaust was provided, insufficient. Basement dryers were vented, but unable to determine if dryers were vented to a common duct with a booster fan. Some exhaust ductwork in the basement mechanical/electrical room was disconnected and in need of repair. There were two, outdated, split system, DX suspended make-up air units located in the roof penthouse. It is assumed these units are providing ventilation air to each tower floor corridor. The updated elevator machine room has a small, split system fan coil unit. The non-updated elevator machine room is just provided with exhaust/ventilation. The majority of the space temperature sensors were original units containing bi-metallic springs or mercury.

It is recommended to replace all of the existing PTAC units with high-efficient heat pump PTAC units. Replace the existing make-up air units and design a system to provide all code-required ventilation air the hallways. All new equipment shall be provided with DDC controls and be connected to a central

DDC system. Install or increase general exhaust in required spaces. Space temperature sensors should be replaced with wireless, electronic sensors and any existing mercury thermostats should be properly disposed.

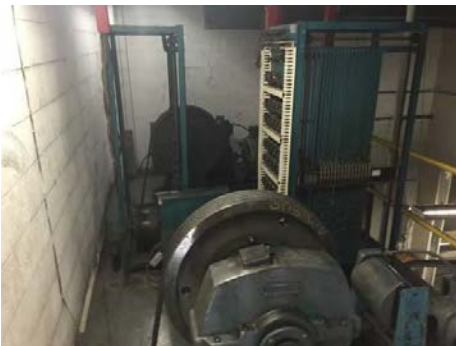
There are two separate elevators, each having two cars, serving each tower respectively. The west tower elevators, machinery and controls were recently upgraded. The elevator cars have the required Firefighters' Operation connections, communications and overrides. The east tower elevator cars, machinery and controls are outdated.

It is recommended to update the machinery, controls and cars serving the east tower. Code-required dedicated cooling and ventilation will need to be provided to the east side elevator machine room.

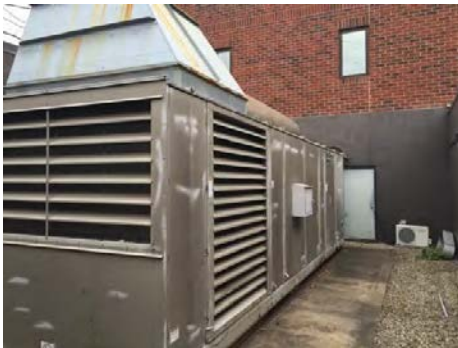
There is a McQuay, VAV, steam heat, split system DX air handling unit located in an exterior courtyard mechanical space. The split-system condensing unit is Carrier and located adjacent to the AHU. Campus steam is serving the AHU; the underground steam piping has been abandoned and now runs overhead to the unit. The VAV AHU has zone level terminal units with electric reheat throughout the majority of the building office and classroom spaces (three story structure). There is small Baltimore Air Coil, forced draft, fluid cooler with discharge dampers, a boiler and pumps serving ducted, water source heat pumps located in the single story first floor spaces. There is a packaged DX roof top unit (RTU) serving the stage/theater space only. There are electric cabinet heaters at most main building entrances. There were many Automated Logic DDC controllers in the mechanical rooms and spaces adjacent to the mechanical equipment. The majority of the space temperature sensors were electronic DDC sensors.

It is recommended to remove the building from campus steam. Replacement options include an onsite steam boiler, or convert/replace the AHU with hot water heating and provide an onsite hot water boiler (Camus DynaFlame to match campus). Budget the replacement of the existing BAC fluid cooler within the next 3-5 years (end of typical unit life span).

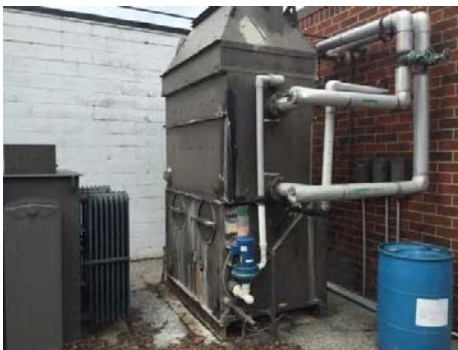
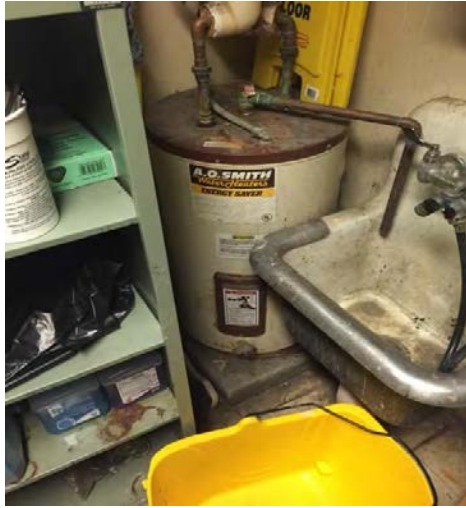
There are AO Smith, 15 gallon, electric water heaters located in the Janitor's closets on each floor. The majority of the urinals and water closets are hands free flush valve type fixtures. The majority of the lavatories have handled faucets. No mixing valves were present at the lavatories which mean the DHW temperature is below 120 deg. F or scalding risks exist. There are electric water coolers throughout the building, most were in good working order. The incoming water service is provided with proper backflow prevention.

It is recommended to investigate the installation of point-of-use thermostatic mixing valves or utilize them for each toilet room or riser and begin to generate 140 deg. F domestic hot water.

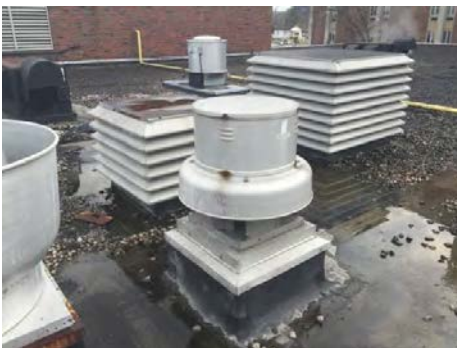
There is a suspended, hot water heating only, make up air (MUA) unit serving the kitchen. The MUA is located in the mechanical penthouse above the kitchen and is a 100% outdoor air unit. Because the MUA is not provided with any cooling, the kitchen can become uncomfortably warm. There are three walls that have kitchen exhaust hoods and cooking equipment. Some of the exposed ductwork appears to be galvanized as opposed to code-required, welded stainless steel or sheet steel. There are three kitchen exhaust fans on the roof; two of the kitchen exhaust fans are long past their expected life span. There are gravity (assumed) make-up air intake hoods that are ducted to the inlet of the kitchen hoods. The gravity approach to providing kitchen exhaust make-up air is inefficient and no longer recommended. The dish machine is provided with ductwork and an exhaust fan; no issues observed with dish machine exhaust (aluminum or stainless). The pressurization between the kitchen and adjacent spaces is not correct, as evidenced by the highly observable airflows into the kitchen at any doorway.

It is recommended to investigate reusing as many of the existing exhaust hoods as possible for any future remodeling. Rework all kitchen exhaust ductwork to be code-compliant. Provide new, variable speed exhaust fans with temperature and/or smoke sensors in the kitchen hoods to only increase the exhaust airflow as cooking demand requires. Provide a cooling coil in the MUA; either chilled water or split DX to allow for some cooling within the kitchen. Provide variable speed, fan forced, heating only, kitchen make up air units designed to meet the majority of kitchen exhaust needs (eliminate gravity hoods) and interlock with variable speed exhaust fans. Provide MUA plenum diffusers along the front edge of all kitchen hoods.

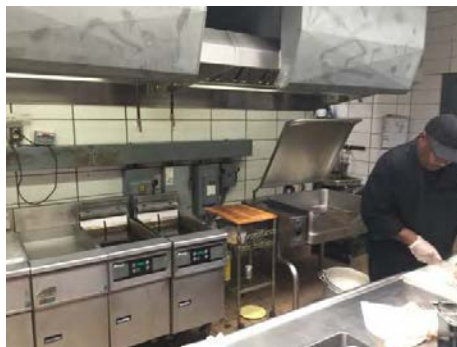
All of the cooking equipment is electric, not gas-fired. None of the walk-in freezers or coolers are provided with rubber strip curtains to help maintain heat transfer when the doors are open. It was mentioned that the coolers and freezers were not insulated from their surroundings when installed, this wasn't able to be verified.

It is recommended to replace as much of the kitchen equipment with gas-fired equipment to substantially reduce operating costs. Properly insulate all coolers and freezers and provide rubber strip curtains
